## An Injury Investigation of a Bus-Train Collision, Chachoengsao, Thailand, October 2020

On October 2020, there was a bus-train collision at Chachoengsao Province with 18 fatalities. The Division of Epidemiology conducted a joint investigation during October 2020 to describe characteristics of the event and deaths, and identify factors associated with fatalities. A descriptive study was conducted by interviewing officers, witnesses, policemen, rescuers and survivors. We also reviewed medical records and closed-circuit television and performed environmental survey of the roads and bus wreckage. A retrospective cohort study was performed with multiple logistic regression and Haddon matrix analyses. The bus collided with a cargo train at an illegal road-railway crossing intersection. Eighteen people died (25.4%). Most deaths were caused by lethal injuries to the head and neck (17/18, 94.4%). The bus was overloaded and turning on loud music. The intersection did not have crossing gates and the warning signal was broken. This bus-train collision resulted in high fatality. Standing on the overloaded bus was the significant risk of death. Regulations of noise limits, number of passenger

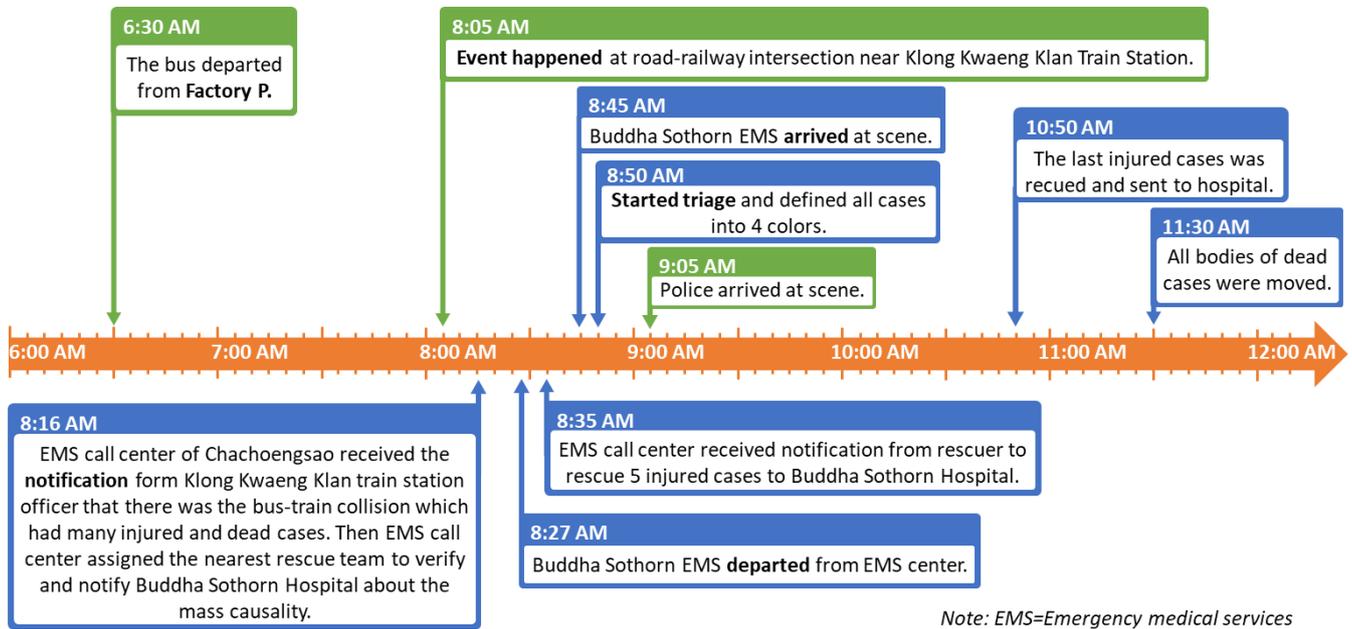
Figure 1. Timeline of the bus-train collision in Chachoengsao Province, 11 Oct 2020

On 11 Oct 2020, a single deck inter-provincial bus carrying 70 passengers and one driver departed from Factory P at 6.30 a.m. heading to Bang Pla Nak Temple in Bang Toey Subdistrict in Chachoengsao Province (63 kilometers from Factory P). On this group tour bus, they opened loud music, sang songs, danced, and drunk alcohol. When the bus crossed a ground-level road-railway intersection near Klong Kwaeng Klan Train Station (60 kilometers from the Factory P), a cargo train heading to Bangkok collided into the bus at 8.05 a.m. (Figure 1). The bus was moving at a speed of 40 kilometers per hour (km/h), according to GPS tracking, as it crossed the railroad tracks and was struck by the train from its right side. Close-Circuit Television revealed the speed of the bus remained consistent while crossing the railroad track. The bus overturned onto its right side, the back of the bus scraped against the moving train and its roof was ripped off. The bus was pushed by the train for 13 meters and stopped in a one-meter-wide groove between the two railroad tracks.

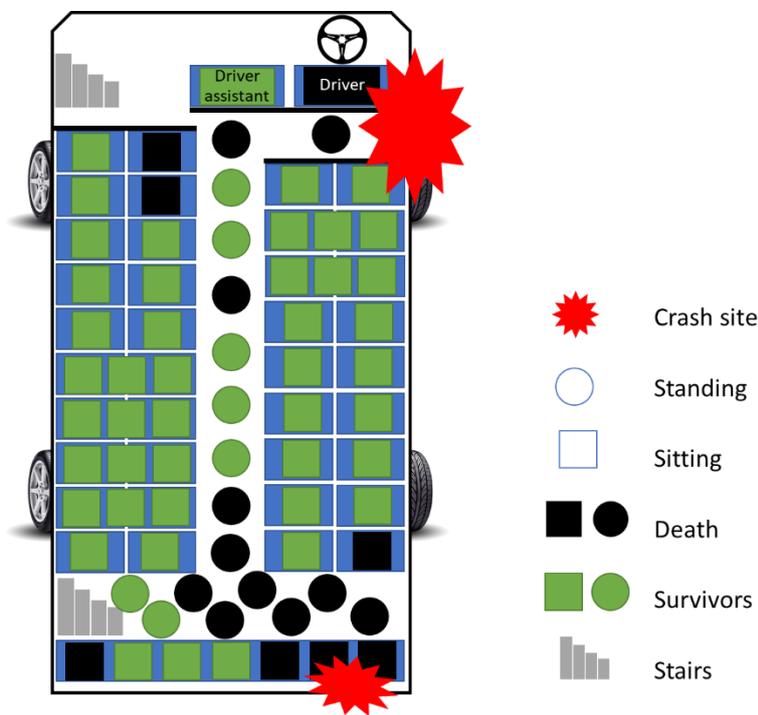
**Figure 2. Seat map of all passengers and driver on the bus of the bus-train collision in Chachoengsao Province, 11 Oct 2020 (n=71)**

The passenger seat map and crash site are shown in Figure 2. The collision occurred at the right side of the bus. Those who were on the right side of the bus were more likely to die than those on the left side. During

the crash, 18 passengers were standing on the bus and 11 died (61.1%) whereas 7 of 53 (13.2%) who were sitting died in this collision.

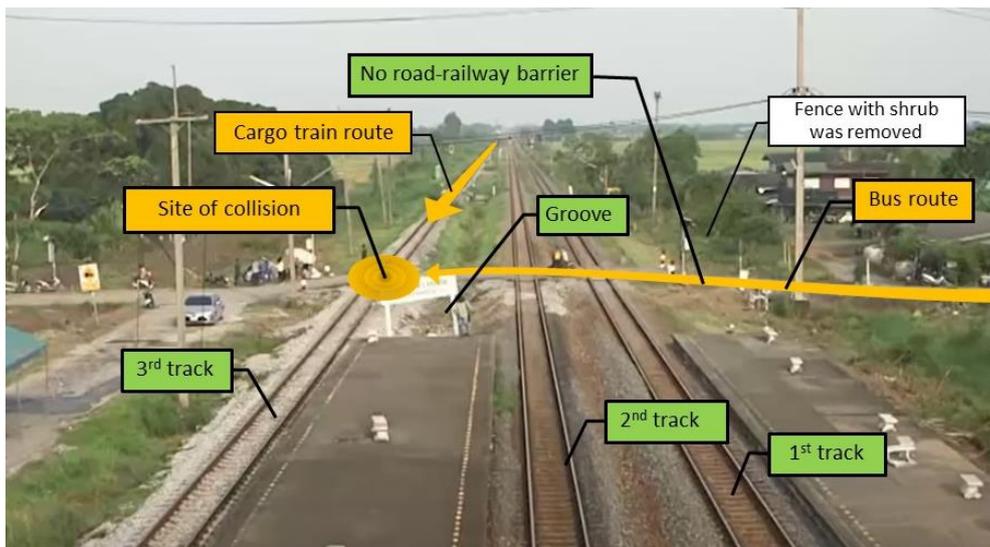
Figure 3. Site of the bus-train collision in Chachoengsao Province, 13 Oct 2020<sup>9</sup>

The collision occurred at an illegal crossing intersection where a two-lane road with opposing traffic crossed three parallel railroad tracks that ran perpendicular to the road. The collision occurred on the third track (Figure 3). The road leading up to the tracks had a 30-degree incline, was made of smooth asphalt, and was approximately 4-6 meters wide. The road-railway intersection did not have a road-railway barrier (a crossing gate). There were two train warning signs approximately 300 meters and 10 meters in front of the railroad tracks. However, the warning light signal was broken. The bus driver's visibility was

obstructed by trees and shrubs, which were removed after the event. (Figure 3). At the time of the collision, it was drizzling, and yaw marks were not observed. The distance from the crash site to the bus wreck was approximately 90 meters and to the train-engine was approximately 600 meters. This event occurred 20 kilometers from the Buddha Sothorn Hospital. It took 30 minutes for the first emergency medical services (EMS) to get to the scene after receiving notification. However, there was a long iron fence blocking the rescue team from getting access to the collision site. Rescue cars were obstructed by a nearby traffic jam. Some survivors were trapped under the wreckage or bodies of the deceased.

We recommend additional safety regulations for noise limits on public transportation to ensure drivers and passengers can maintain optimal levels of awareness of the surroundings. In addition, regulations regarding public bus licensing, number of passengers, seatbelt use, and driver's visibility should be strictly implemented. Office of Land Transport should promote fastening a seat belt on public transportation (especially long-distance routes) and limit standing on the buses (especially inter-city buses). Local administrations and State Railway of Thailand should jointly improve safety control for all illegal road-railway intersections including warning signs, adequate visibility, and intersection barriers. The local emergency response protocol should be reviewed to address the delayed response.
